US Army Corps
of Engineers

TECHNICAL REPORT REMR-CS-4

REPAIR OF WATERSTOP FAILURES: CASE HISTORIES

James E. McDonald

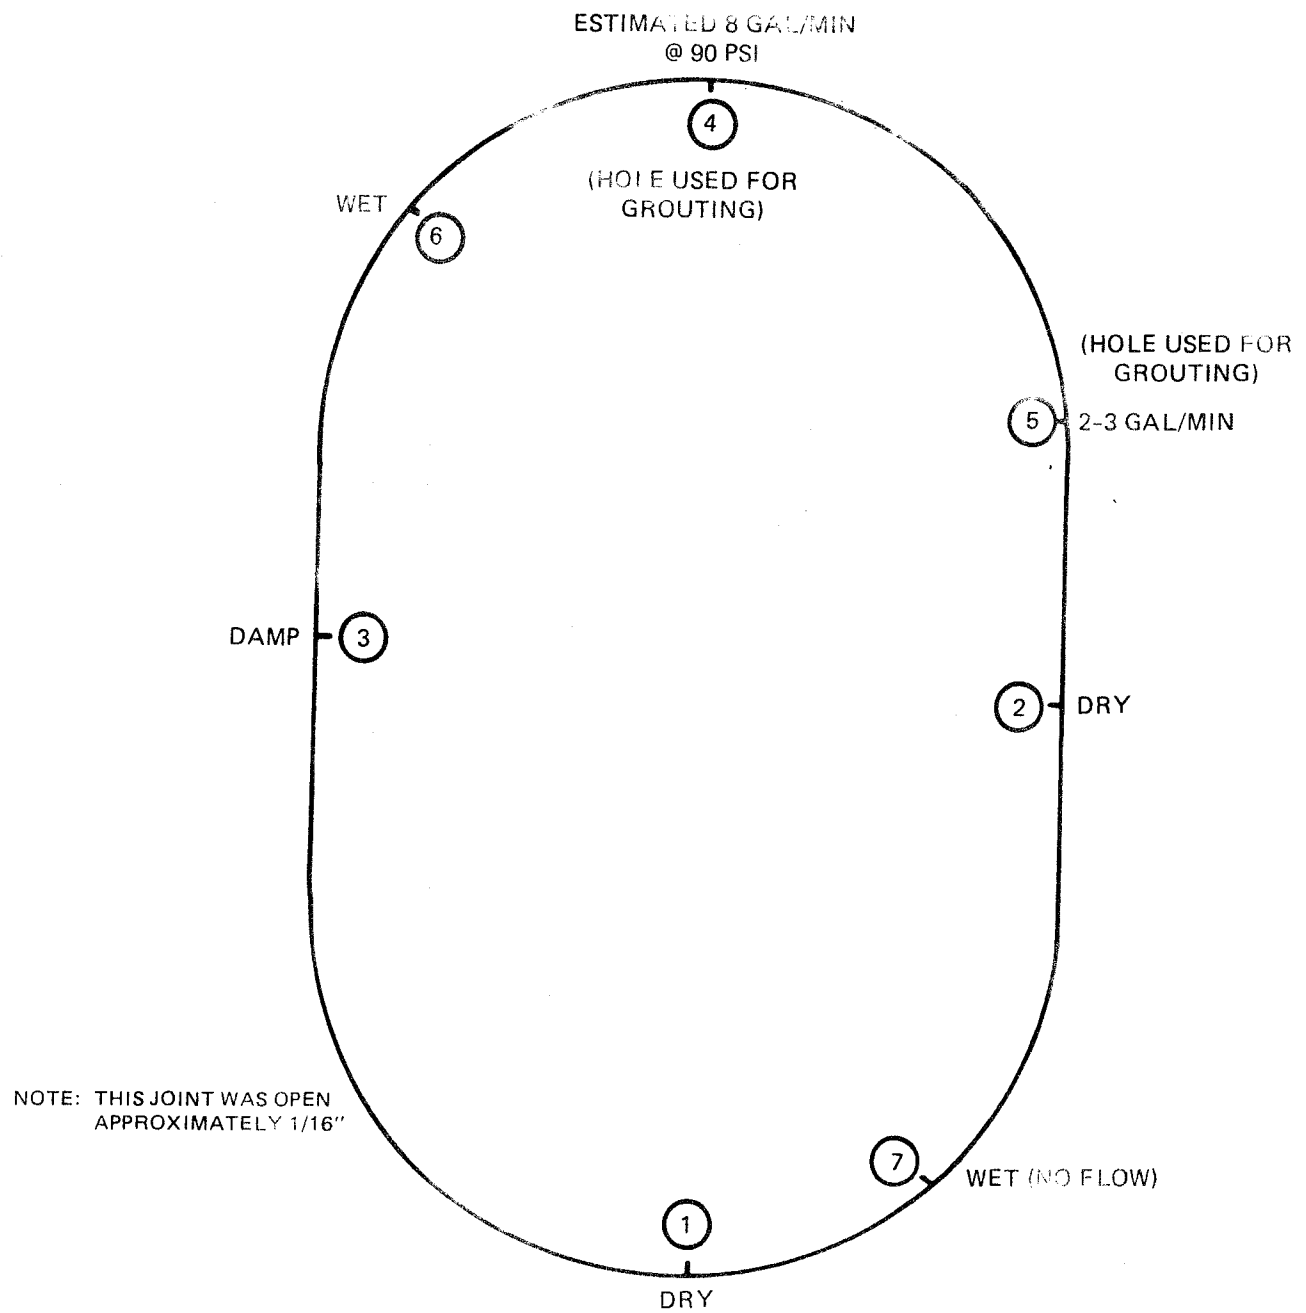
Figure 127. Section at joint 12/13 looking upstream, Applegate Dam

250. Leakage of 1-3 gal/min was noted at several joints when the conduit was inspected in June 1985. However, there was no leakage reported at joints 12/13 and 15/16, which were chemically grouted in July 1984.

247. On 28 July, seven holes were drilled at joint 12/13 with the 5/8-in.-diameter Rotohammer (Figure 127). Hole No. 4, in the crown, had the largest flow and greatest pressure prior to grouting of any of the drill holes in either joint. Hole No. 4 was grouted first. Pump pressure built up very rapidly and was at 240 psi after 5 minutes when grouting was stopped. The grouting successfully stopped the slight leakage along this joint. Prior to grouting hole No. 5 water pressure was measured at 90 psi. Hole No. 5 took 10 gal of CR 250 grout with no grout pressure buildup. The hole was plugged after 5 min and it was assumed the grout was venting to the gravel fill. An attempt was made to grout the other holes but there was no take in any of them. All holes were backfilled with Preco Plug and the repair was completed at 8:30 p.m. on 28 July.

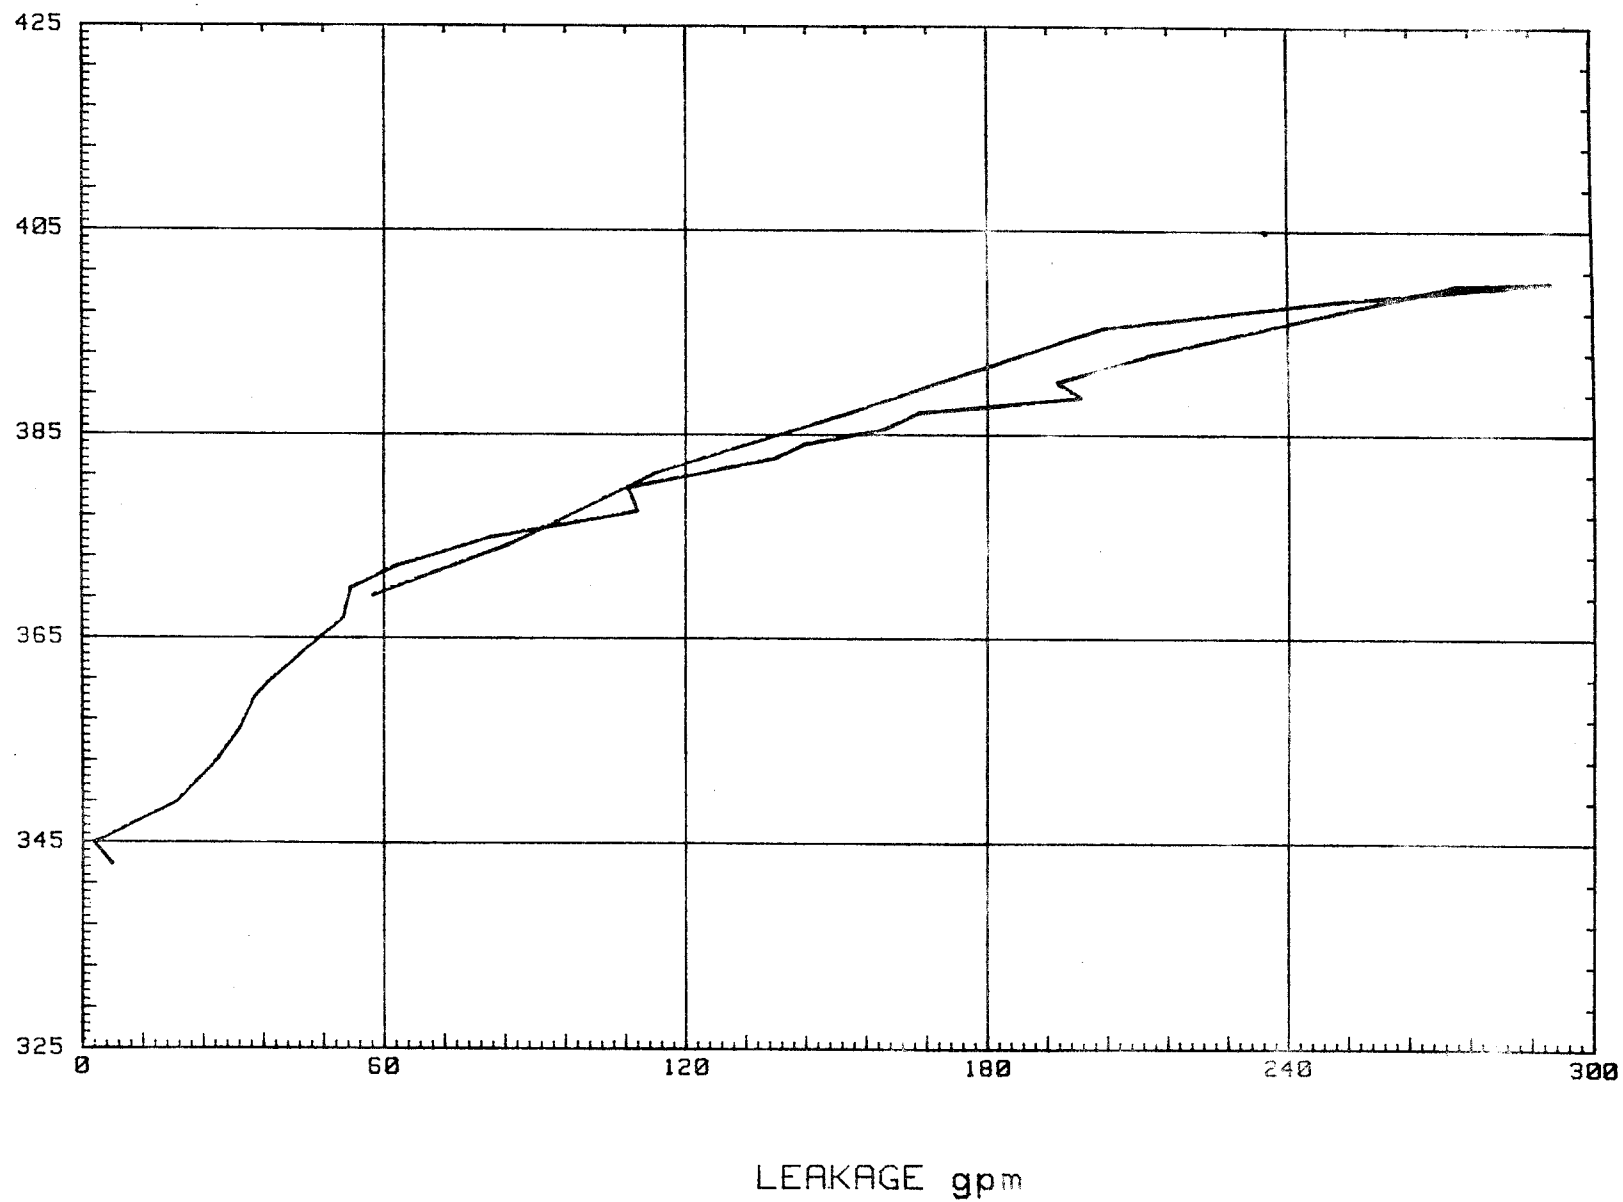
Figure 136. Leakage measurements, Richard B. Russell Dam, 6-15 June 1983

270. After test repairs on the five joints were completed, the pool was again raised to elevation 400 ft to evaluate the effectiveness of the repair. The sluice gates were closed on 6 June 1983 when the lake was at elevation 342.1 ft. As the lake level began to rise, leakage was measured at approximately 5-ft intervals until the lake reached elevation 400 ft on 10 June. The sluices were opened 11 June, and the lake was allowed to fall. The monitoring process continued through 15 June, as the lake stabilized at elevation 360 ft, with results as shown in Figure 136.

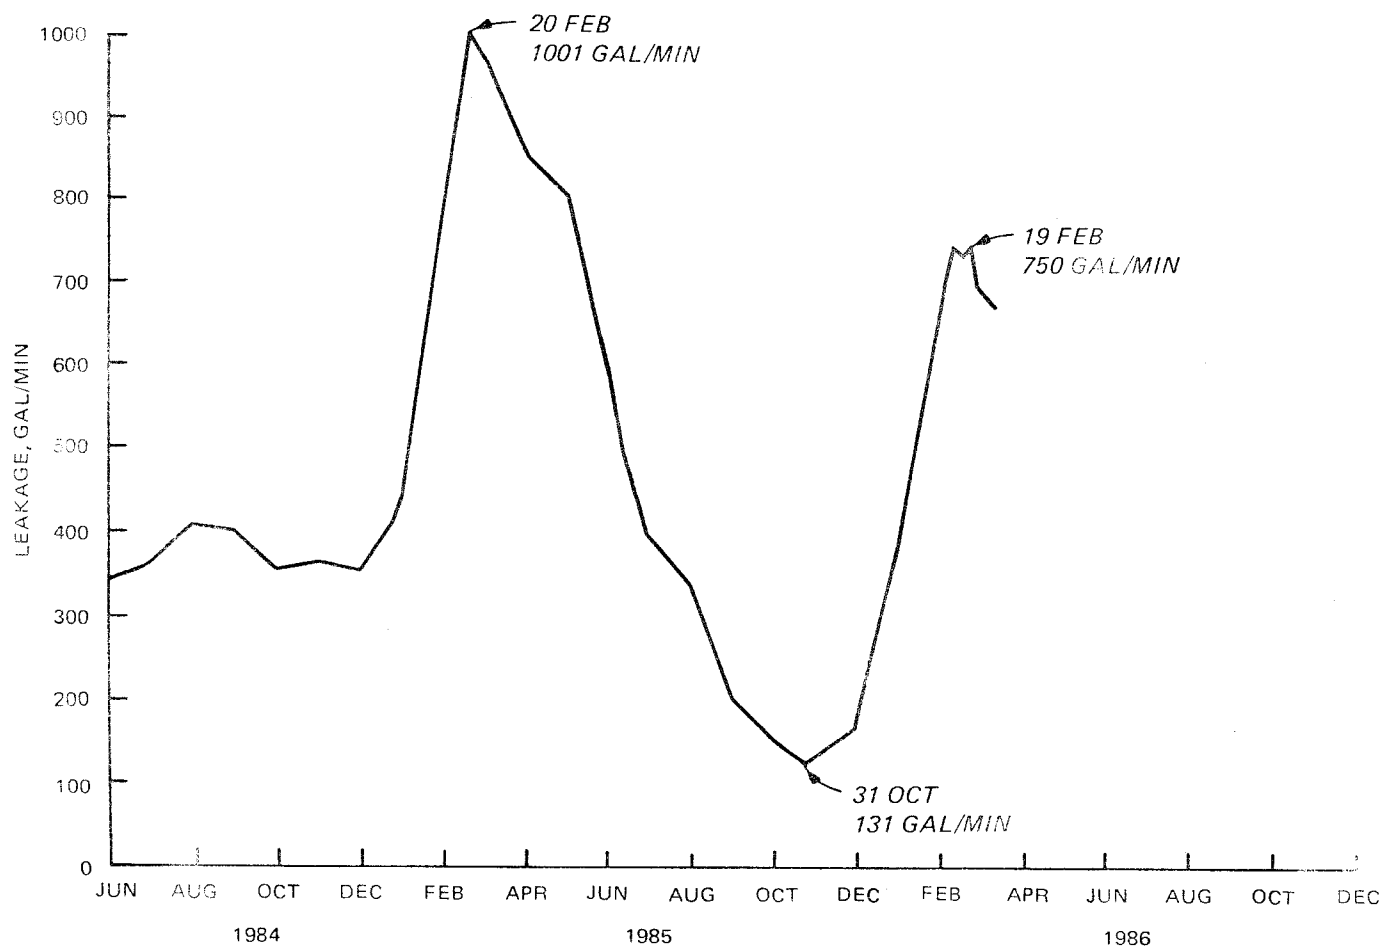
Figure 143. Results of leakage measurements, Richard B. Russell Dam

repairs, a maximum leakage of 1,001 gal/min was recorded on February 20, 1985 followed by a steady decline to 131 gal/min on October 31, 1985 (Figure 143). In 1986, the maximum leakage of 750 gal/min was recorded on February 19. Continued measurements and observations are planned through another winter cycle. Based on experience at other dams, it is believed that the formation of calcium carbonate will further reduce the leakage.

283. Phase II repairs, undertaken while the lake rose approximately 75 ft, reduced the leakage from approximately 950 to 350 gal/min. In addition, it is believed that the repair also kept the leakage from increasing substantially as the pool was raised. Therefore, the repairs were considered to be an overall success. Regarding individual repair methods, the use of Silva-Cel wood fibers, cinders, and bentonite had no noticeable effect on stopping the leakage. Application of an external sheet rubber waterstop was only temporarily effective due to failure of the bonding agent. Underwater grouting from the reservoir side was very difficult and only partially effective. The application of fiberglass-epoxy resin strands and patches on the exterior of the concrete dam under water produced very good results. Grouting from the gallery interior was effective, but it was difficult to keep the grout out of the drains. Two drains were clogged, one intentionally.

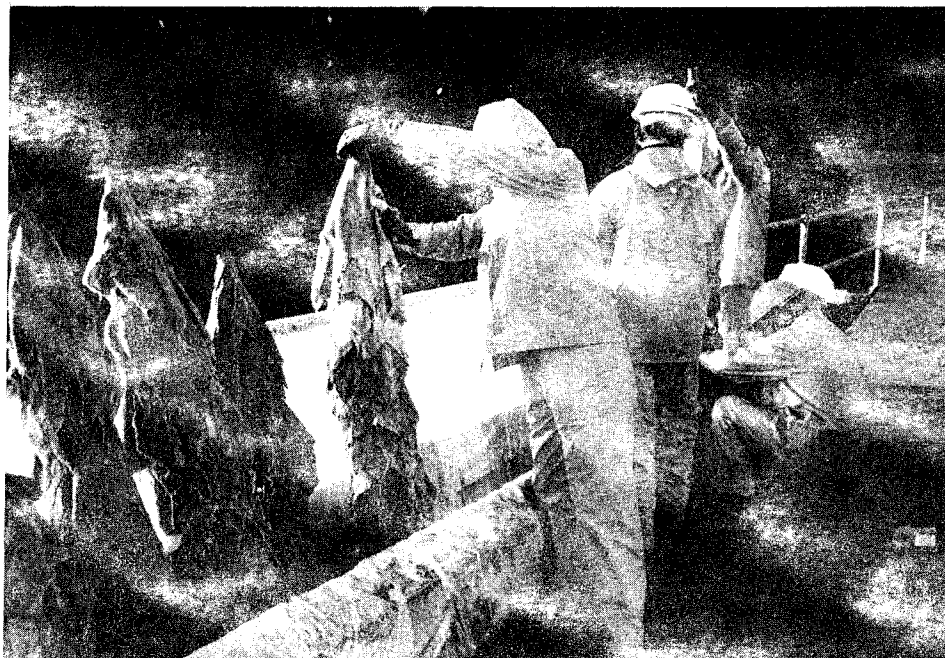
Figure 144. Soaking burlap "Christmas trees" in polyurethane foam grout, Easton Reservoir Dam

287. The grout used was TACSS Flex 44, a polyurethane foam with Environmental Protection Agency (EPA) approval for use around potable water. Because of concerns about the grout being washed through the joint before it set, the grout was not pumped directly into the hole. Burlap was cut into 24-in. squares and attached to a 1-1/2-in.-diameter plastic pipe on approximately 1-in. centers with the pipe through the center of the burlap squares. The pipe sections with the burlap attached were soaked in a long trough filled with the Flex 44 grout (Figure 144). The pipe was removed from the trough and after the excess grout drained off, the pipe was inserted into the hole (Figure 145). The pipe sections were designed to fit together rapidly and lock so the entire 35-ft length of hole could be filled with the burlap and grout

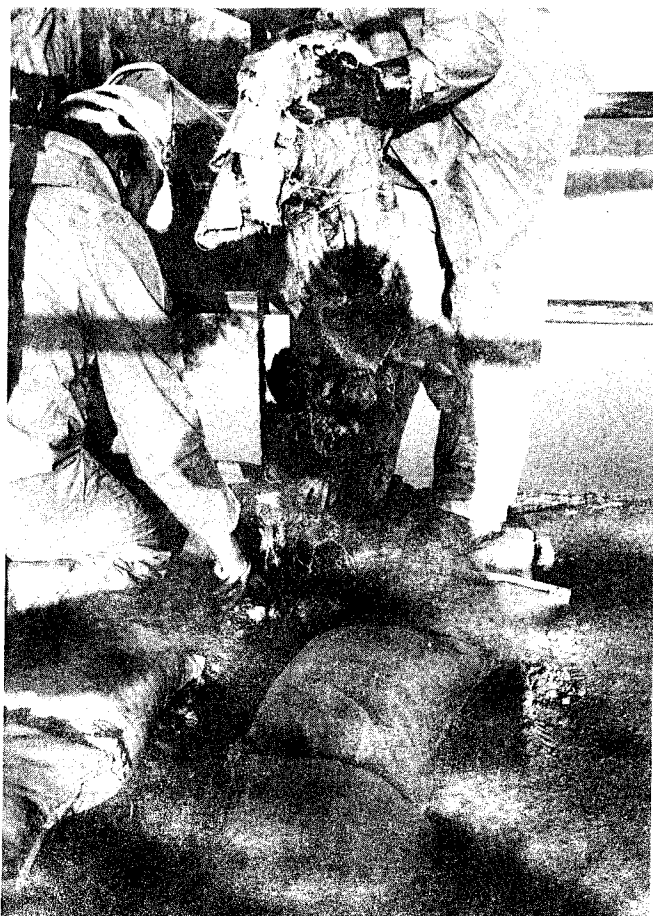
Figure 145. Installing "Christmas tree" in the drill hole, Easton Reservoir Dam

before the grout started to form. This arrangement allowed for positive placement of the grout and removal of the "Christmas tree," if required during installation, before the grout formed. Because most of the holes were dry, water was pumped into the hole after the "Christmas tree" was placed to activate the form. The holes were capped flush with the roadway surface using a concrete plug.

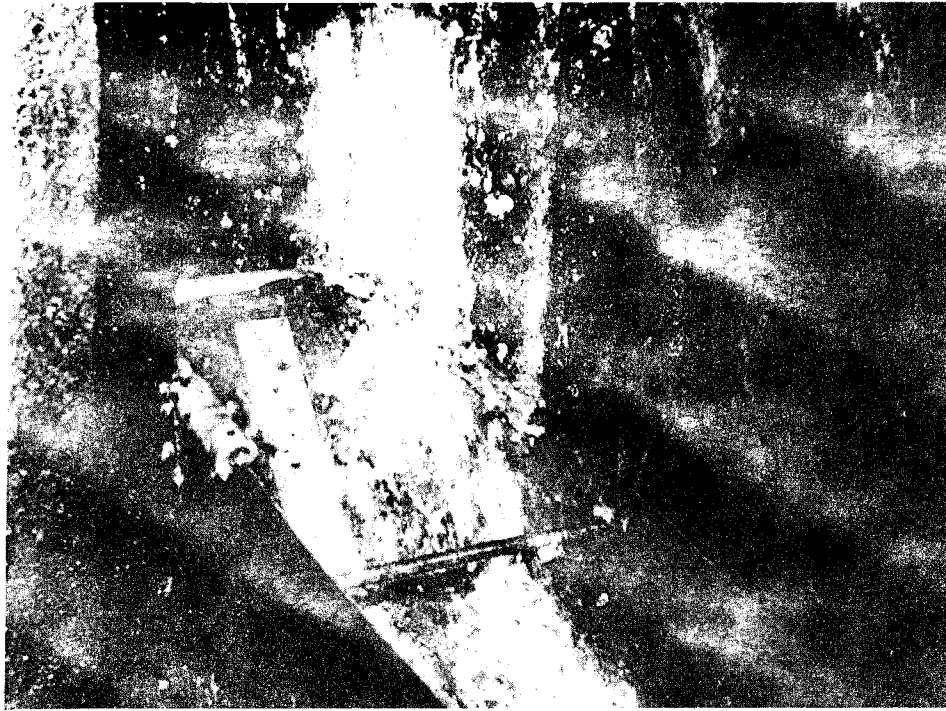
289. In 1984, Union Electric contracted with Structural Preservation Systems, Inc. (SPS) to stop leakage between concrete monoliths of six vertical joints in the west nonoverflow section of the dam. Water from the reservoir leaking through the vertical drainage system could be seen (Figure 146) and measured in a dam gallery which runs approximately 83 ft below the roadway surface. These vertical drains empty into a large horizontal drain at the bottom of the dam. In addition, there are horizontal drains at each lift joint that feed into the vertical drains. On 2 April 1984, joint leakage ranged from 50 to 660 gal/min with an average flow for the six joints of 211 gal/min.

a. Joint 15 with hole drilled to a depth of 10 ft

b. Joint 17 prior to drilling

Figure 146. Leakage of joints 15 and 17 as seen in the gallery, Bagnell Dam

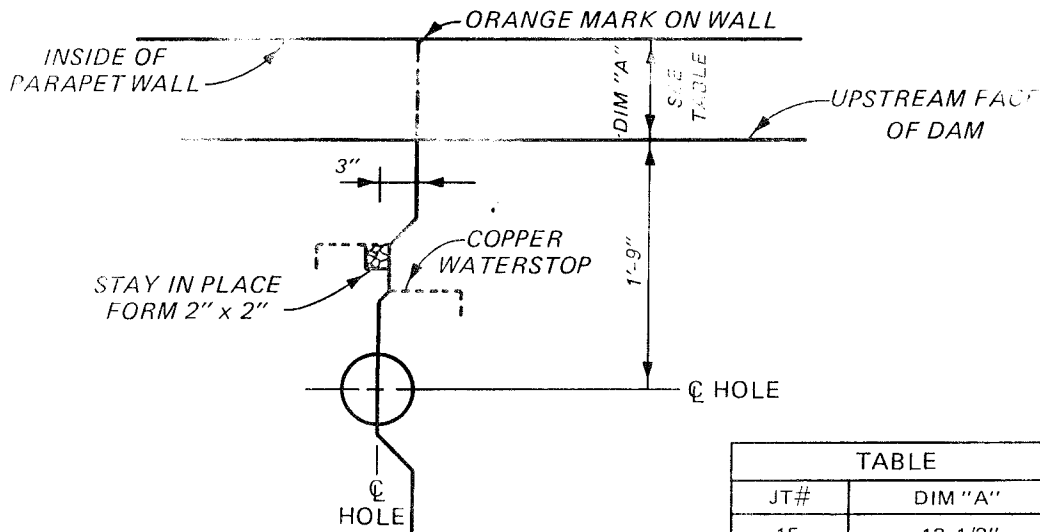
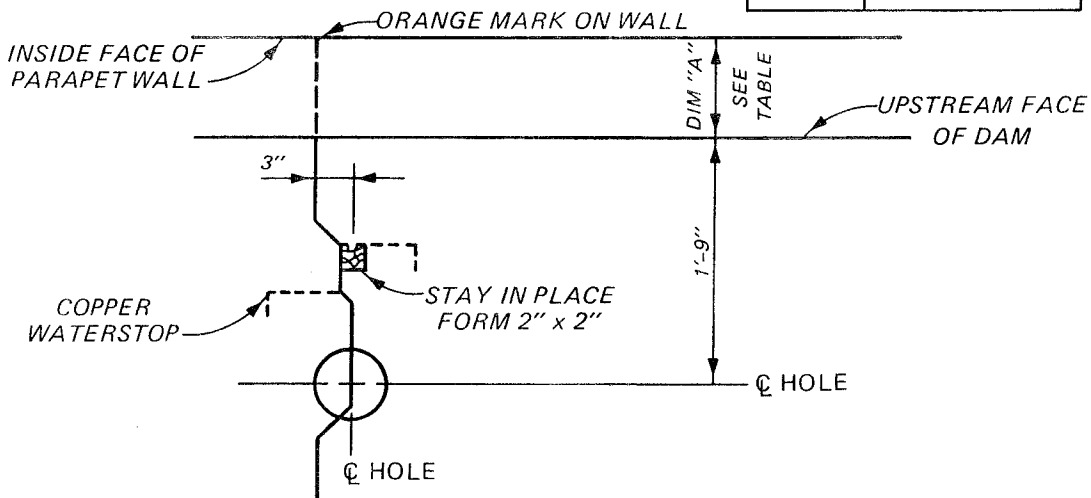
Figure 147. Drill hole locations, Bagnell Dam

293. The apparent wandering of this first hole was attributed to two factors. First, the video showed that the concrete around the waterstop was fragmented and poorly consolidated. Since the theory behind the down-the-hole hammer is that it will follow the weakest plane, it followed the weakened plane along the waterstop. Second, there were several attempts to correct the alignment (away from the waterstop) which may have actually worsened the alignment. The drilling of the first hole was accomplished in 34 hr of drilling; its final depth was 154.8 ft, and it was completed on 14 April 1984.

291. Construction Drilling, Inc. (CDI), the drilling subcontractor, began mobilizing on 3 April 1984. The mobilization took about a day and a half because numerous patches in the roadway had to be planked and bridged over, a requirement of the Missouri State Highway Department. CDI used an Acker track-mounted drill rig with many modifications specifically for drilling with a down-the-hole hammer. Drilling was accomplished with a 6-in. down-the-hole hammer, a type of rotary/percussion drilling equipment. The head of the hammer pounds as it rotates. At 150 psi, the hammer is operating at approximately 1,000 blows/min. This rate varied as the air pressure at the hammer changed due to depth and frictional losses. In addition to the down-the-hole hammer, a 6-in. core barrel was used to obtain concrete core to verify joint location in the borehole. Drill hole locations are shown in Figure 147.

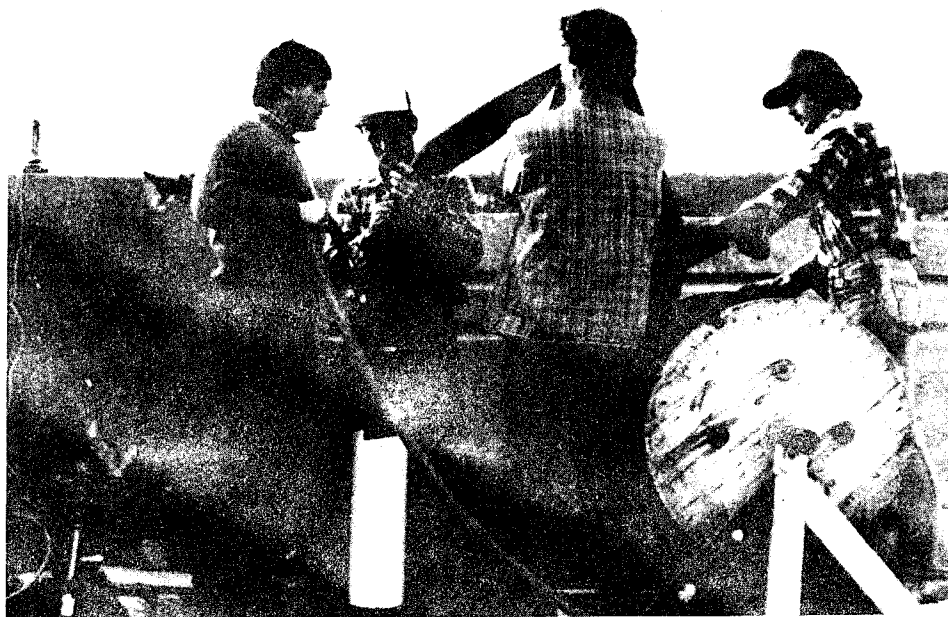
Figure 149. The inversion process underway, Bagnell Dam

The theory was that the weight of the water would unroll the sleeve in the hole. A cable was to be attached to the sealed end of the inner sleeve for ease of removal of the sleeve.

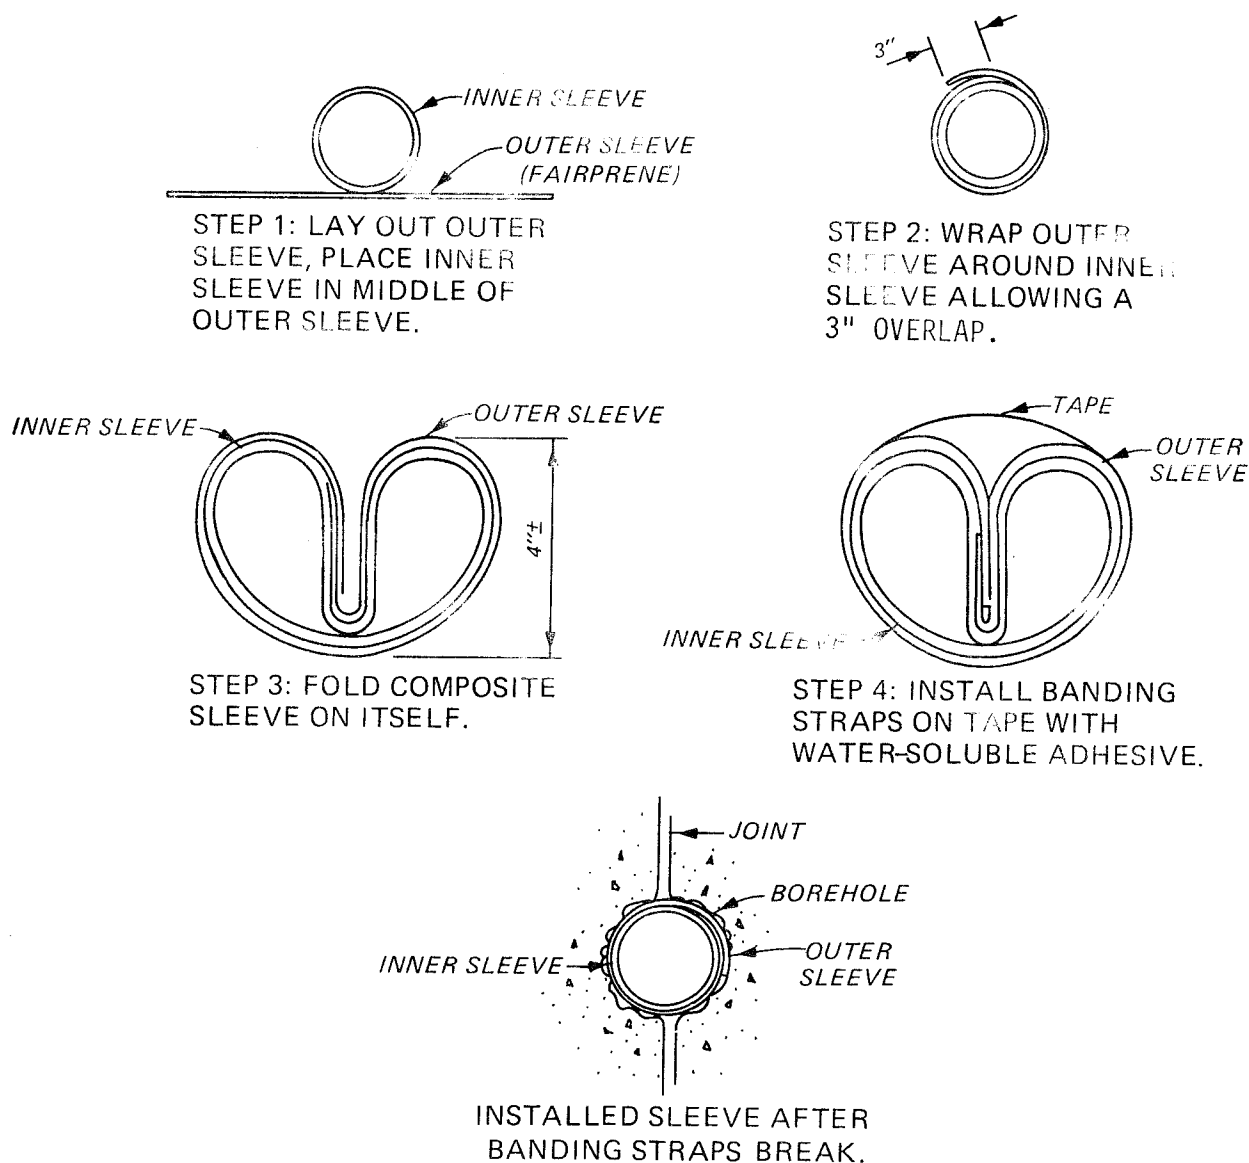
Figure 150. Sleeve installation procedure, Bagnell Dam

304. Subsequent to the failure of the inversion process, an alternate method of installation was employed. This method involved the insertion of both sleeves simultaneously (Figure 150). This was accomplished by weighting one end and lowering the composite sleeve into the hole. This method proved to be fast and effective, and was used in installing all five sleeves. A detailed description of the preparation and installation procedure follows:

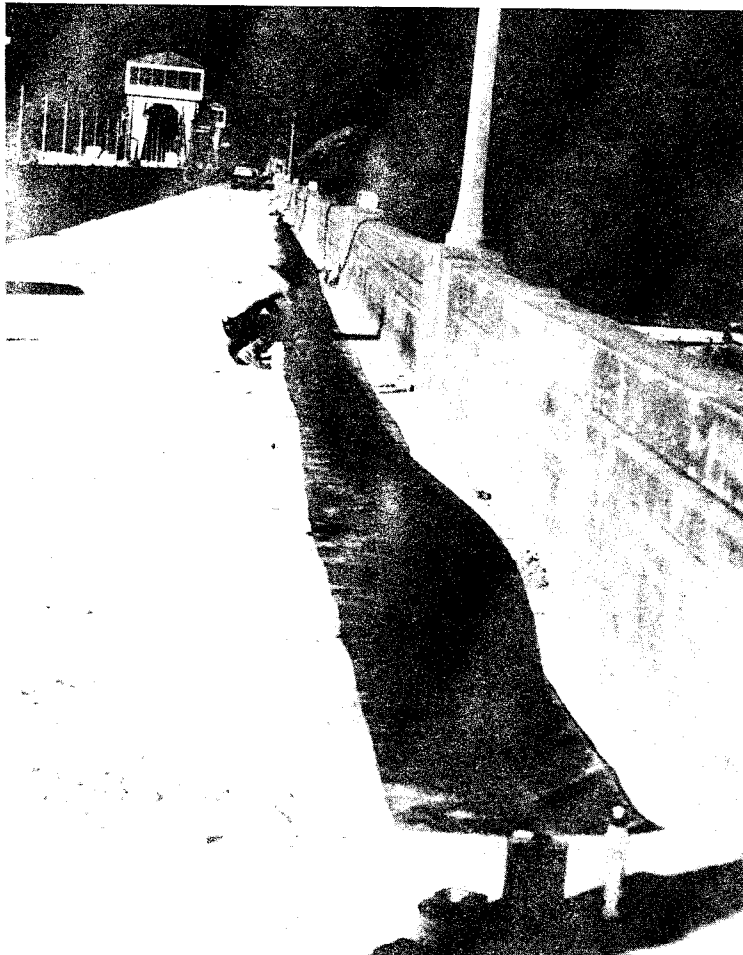
Figure 151. Soap testing the inner sleeve,
Bagnell Dam

- a. The outer sleeve was rolled out on the roadway deck and cut to the appropriate length. Next, the inner sleeve was placed on the outer sleeve and a packer placed in its open end. Approximately 10 psi of air was then induced into the inner sleeve and it was soap tested for leaks (Figure 151). In the event that any leaks were found, they were repaired by patching with a commercially available tire patch and vulcanizing fluid, a method approved by Rubber Engineer Company.
- b. Once the leak test and any necessary patching was complete, a 10-lb weight was attached to the end of the composite sleeve. The weight consisted of either a piece of 1-1/2-in.-diameter

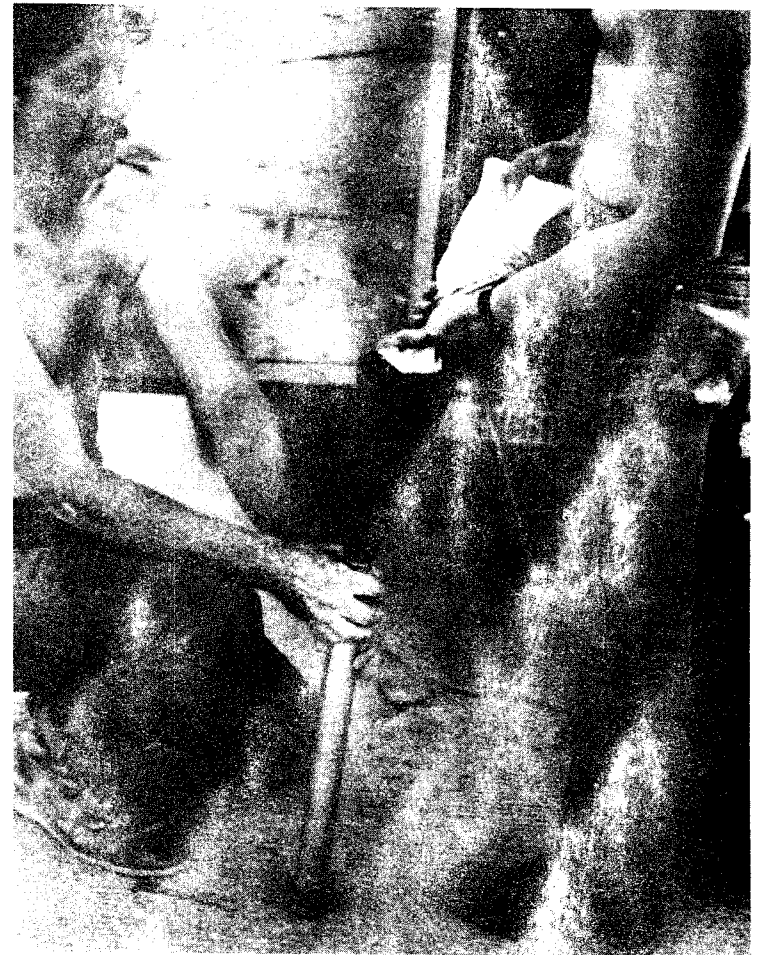
Figure 152. Steel pipe filled with lead shot
to weight the composite sleeve, Bagnell Dam

steel pipe filled with lead shot, a piece of 2-in.-diameter polyvinyl chloride pipe filled with lead shot, or a lead doughnut 4 in. in diameter (Figure 152).

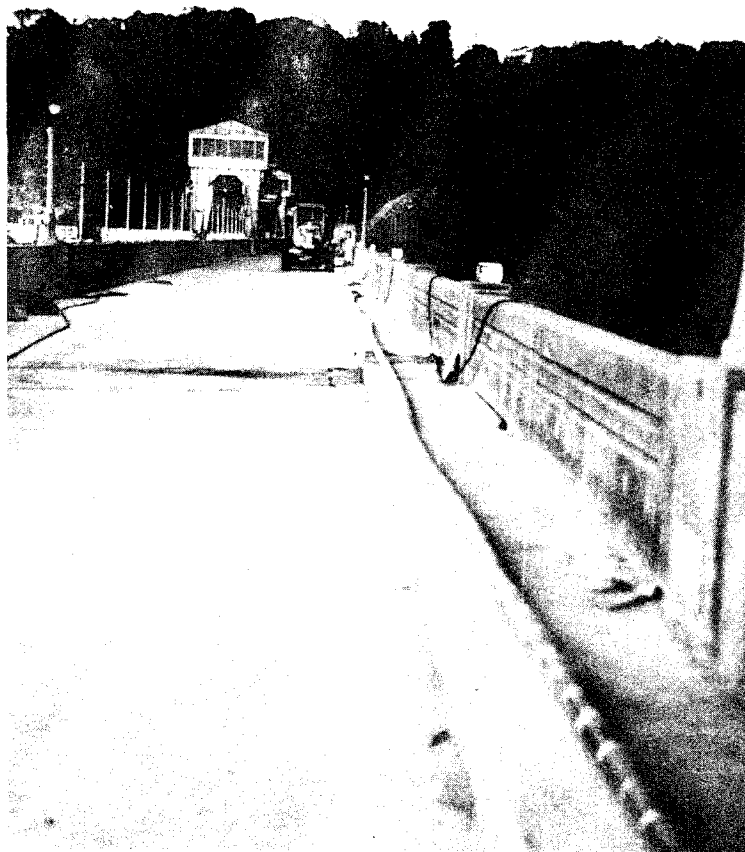
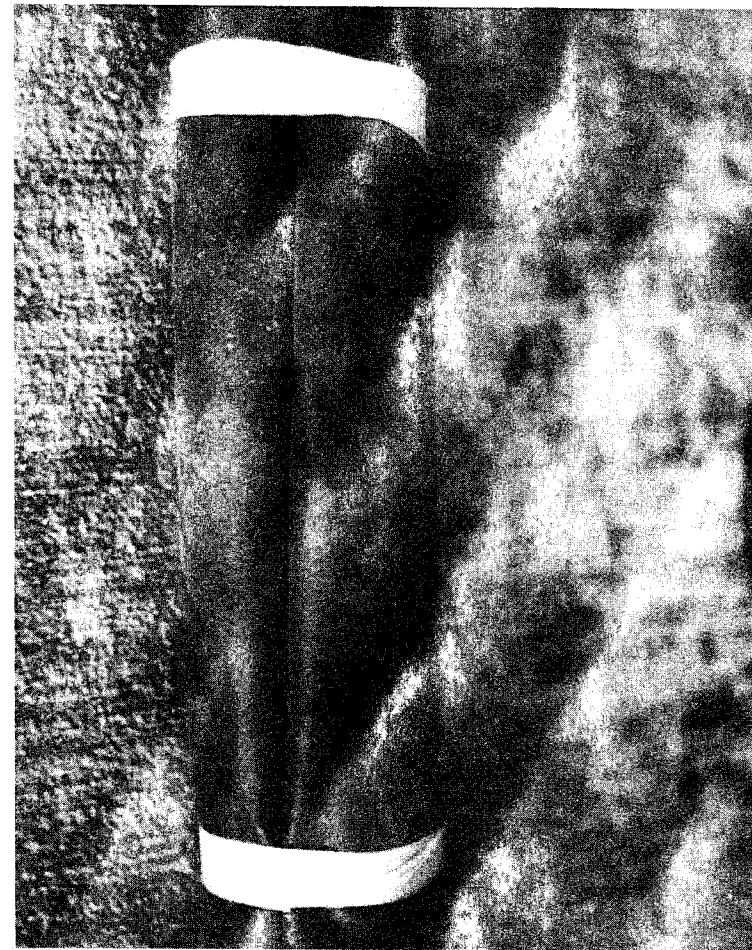
Figure 153. Composite sleeve ready for installation, Bagnell Dam

diameter and secured with masking tape bands spaced at approximately 12 in. on center (Figure 153).

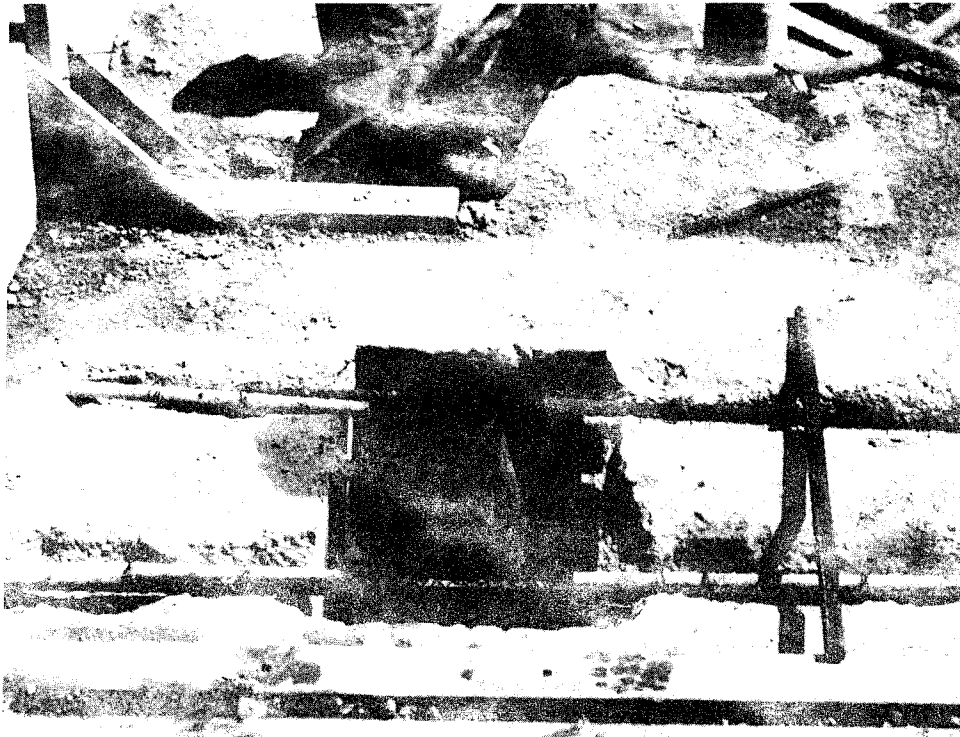
Figure 154. Composite sleeve installed, Bagnell Dam

- e. After the sleeve was prepared and the final video of the borehole completed, the composite system was lowered in the hole, weighted end first. When the composite sleeve was at the bottom, it was rolled over and attached to a temporary flange at the roadway surface (Figure 154). The outer sleeve was marked at 10-ft increments so that it was known that the sleeve was actually lowered to the bottom of the hole.
- f. Once the sleeve was in the bottom of the hole, it was filled with water. Because of the weight of the water and the fact that the adhesive on the masking tape was water soluble, the banding straps would break and the sleeve would seat against the borehole walls.

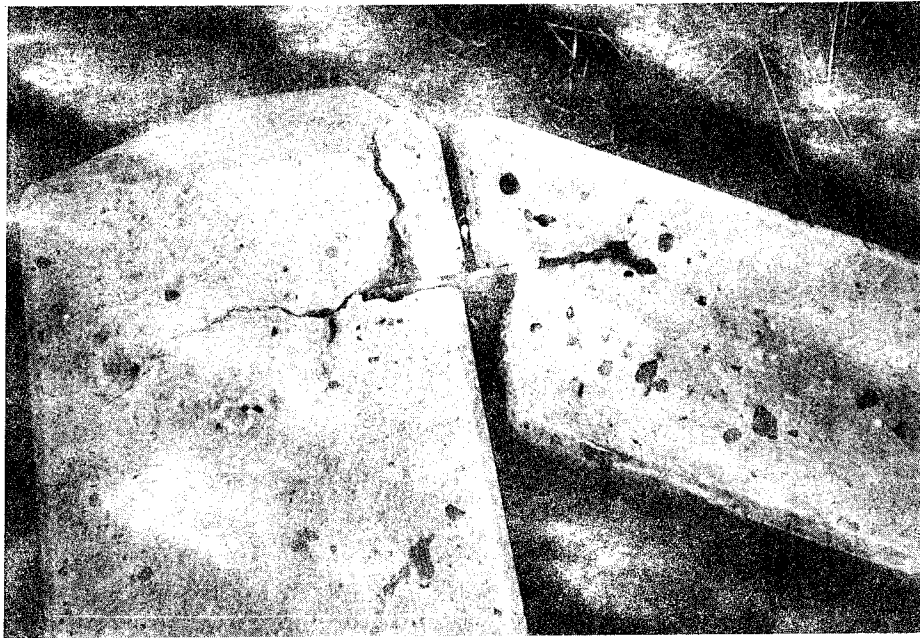
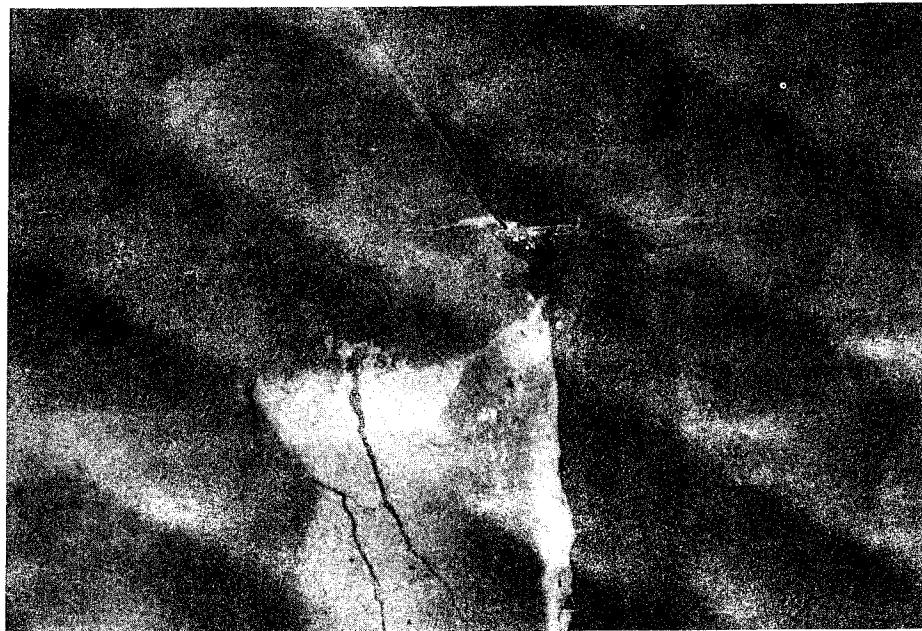
Figure 160. Typical concrete cracking and spalling
around the steel plate waterstop, Caruthersville
Floodwall

310. Concrete cracking and spalling around the monolith joints (Figure 160) was repaired in 1984. Also a new waterstop was installed in 22 of the joints. The center portion of the existing waterstop was removed by drilling a 4-in.-diameter core vertically at the intersection of the steel plate and the joint. A one-piece diamond drill bit 13 ft long was used to core the holes to a depth of 12 ft. The one-piece drill bit was used because the core was divided into four sections by the steel plate and the joint filler and would not stay together in one piece. Also, even if all four pieces of concrete were removed, the drill operators could not free the steel plate until the hole was drilled all the way through the wall. If they had tried to drill deeper after a section of the core was removed, the steel plate probably would have locked up inside the drill bit, causing it to jam. Torque created by such a bit jam could have stripped the threads between the tube sections used to lengthen the drill bit.

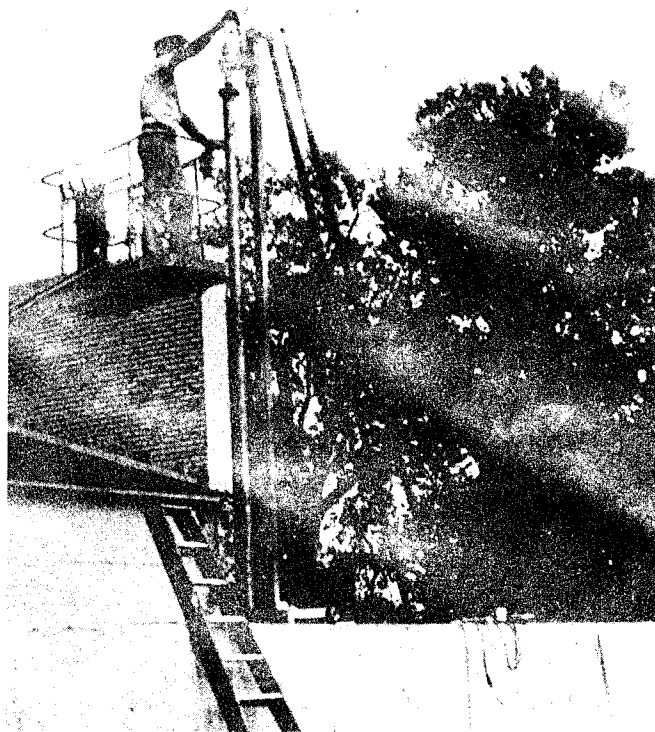
Figure 161. Drilling through existing waterstop, Caruthersville Floodwall

311. The 8-hp air drill was mounted on a 15-ft-high mast that was anchored to the top of the floodwall. Operators had to work from a manlift (Figure 161). Asphalt in the joint filler tended to gum up the drill bit and cause it to jam also. To minimize this, the drillers used a mild soap solution to lubricate the bit. The drill bit still jammed up, however. When this happened, operators had to remove the bit; but when they did this, the concrete and joint filler also often came out. The steel plate remained embedded in the concrete at the bottom of the hole. To keep the plate from flopping around and locking up inside the tube when drilling was resumed, they filled the cored portion of the hole with low-strength grout and then redrilled the entire hole. Because of bit jams, some holes took 7 to 10 days to drill and others took only 1-1/2 days. Dixie Construction Products, Atlanta, Georgia, was the drilling contractor.

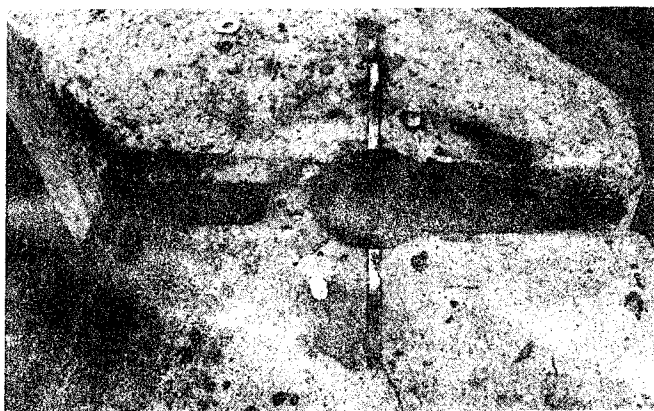
Figure 162. Drill hole prior to grouting, Caruthersville Floodwall

312. After the holes were drilled (Figure 162), they were filled with a flexible grout. FLEX 44, a polyurethane grout distributed by De Neef America, Inc., was used to fill the holes. When FLEX 44 comes in contact with water, it expands and solidifies into a closed-cell flexible sealant. After the grout was mixed by hand with 10 percent water in a bucket, each hole was filled approximately one-third full (Figure 163). The top of the hole was then blocked and through expansion of the grout the remainder of the hole and adjacent joint was filled with the flexible grout.

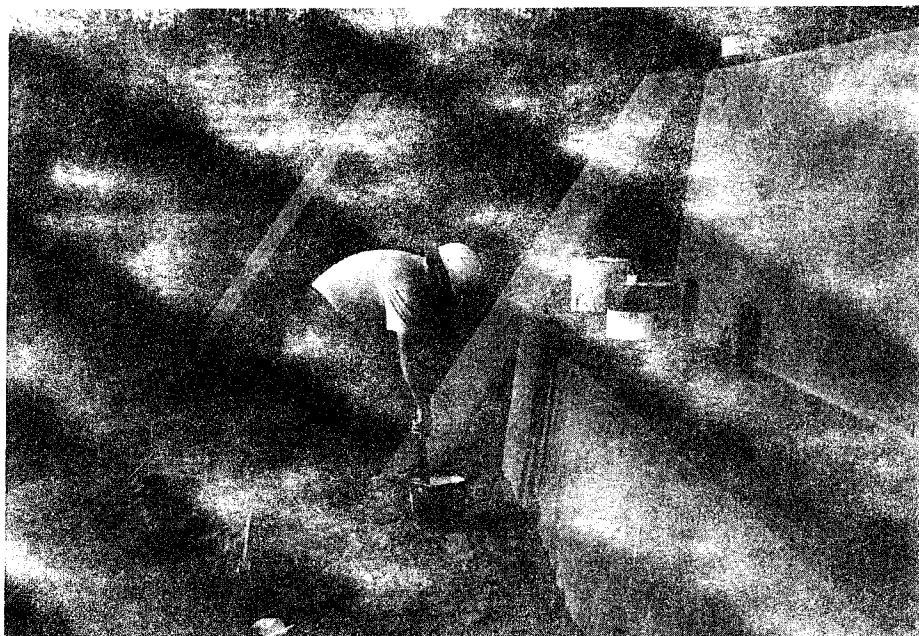
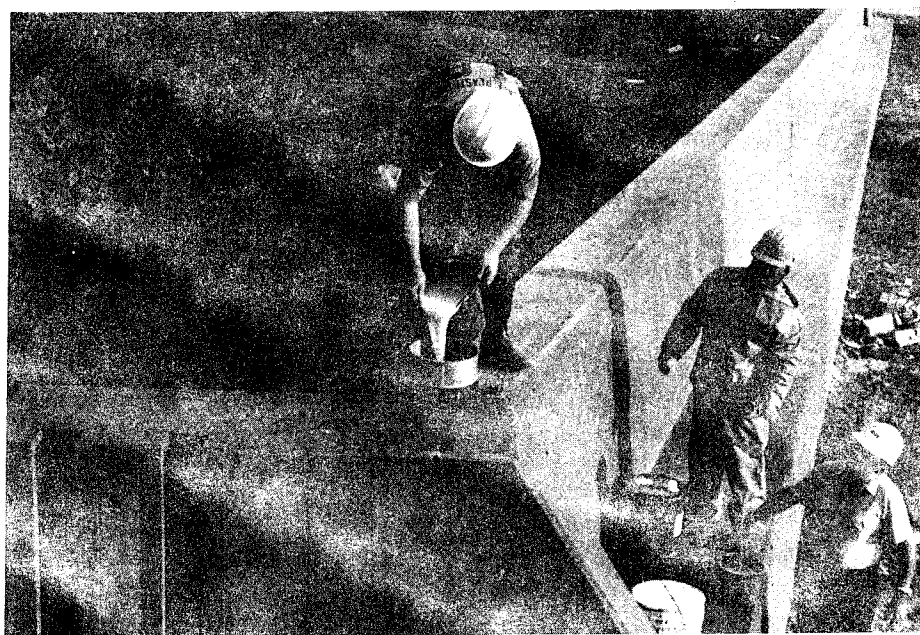
Figure 163. Mixing and placing polyurethane grout, Caruthersville Floodwall
